**Docket No. 217 – Development and Management Plan Inspection**

Northeast Utilities Service Company Certificate of Environmental Compatibility and Public Need for the construction of a 345-kV electric transmission line and reconstruction of an existing 115-kV electric transmission line between Connecticut Light and Power Company's Plumtree Substation in Bethel, through the towns of Redding, Weston, and Wilton, and to the Norwalk Substation in Norwalk, Connecticut.

**Date:** September 1, 2005

**Location:** 345kV Underground Route

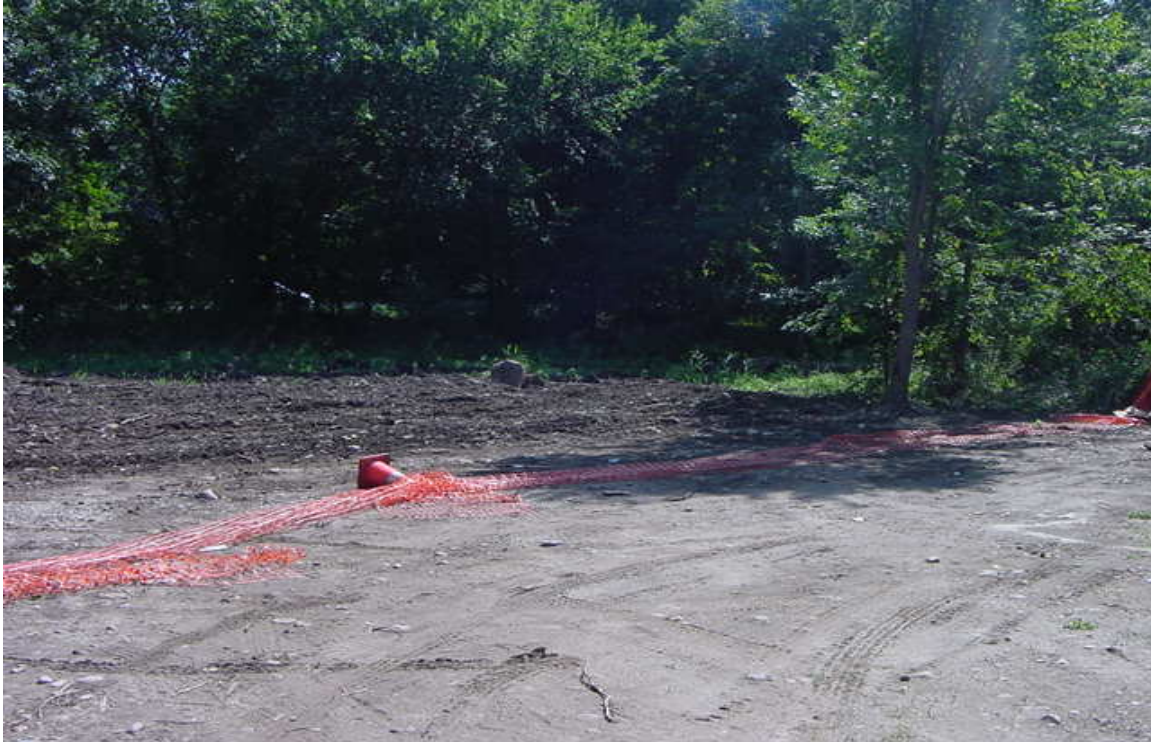
345kV (Route 7 Wilton): View of the School Rd. area where disturbed soil should be temporarily stabilized unless the staging work occurs here soon. (9/1/05)

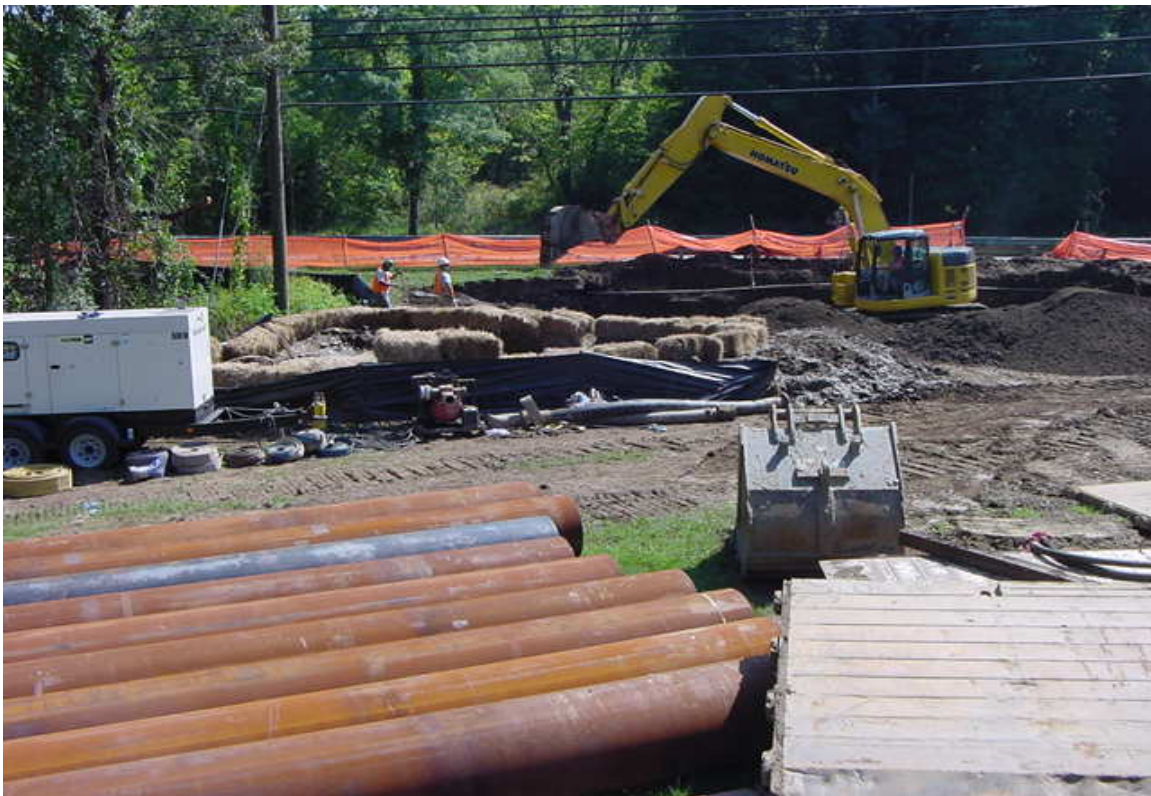
View of the jack and bore operation including the settling basin near Allens Meadow Park. The actual bore is almost done and the jacking pit is being partially backfilled. A receiving pit will now be under construction. (9/1/05)

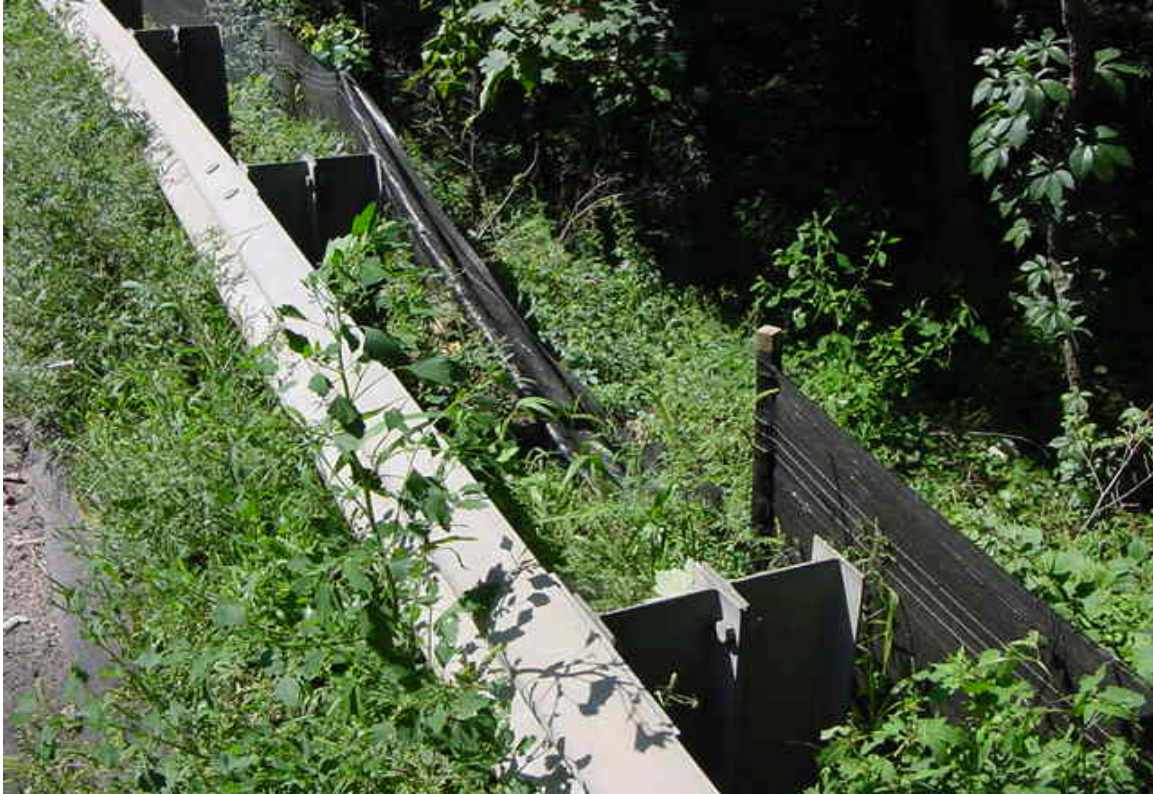
One of the areas along Rt. 7 where silt fence is down. Maintenance is **not necessary until** work returns to the adjacent roadway. (9/1/05)

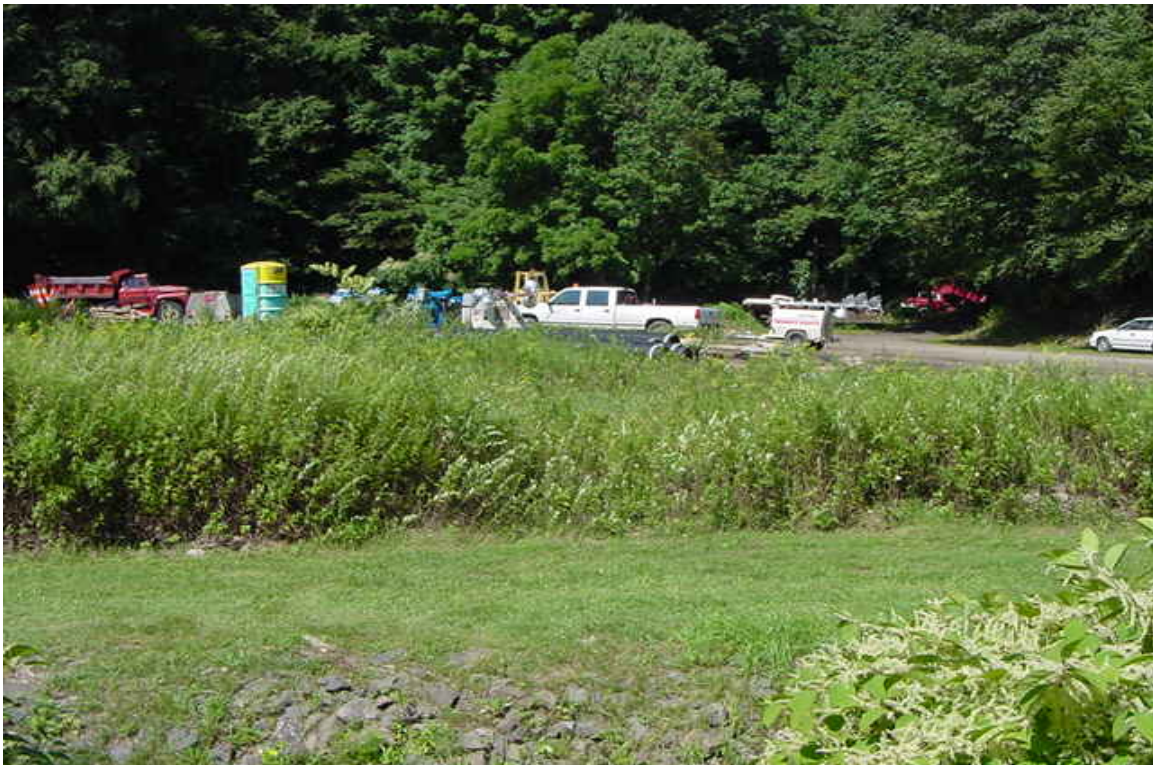
View of the storage yard near the Rt. 107/7 intersection. Silt fence will be restored following the landowner's activities which pulled it down. (9/1/05)
